# Repair of Damage to Marine Sandwich Structures: Part II - Fatigue Testing

*M.Z. Shah Khan and I. Grabovac*

**Maritime Platforms Division**  
Aeronautical and Maritime Research Laboratory

DSTO-TN-0275

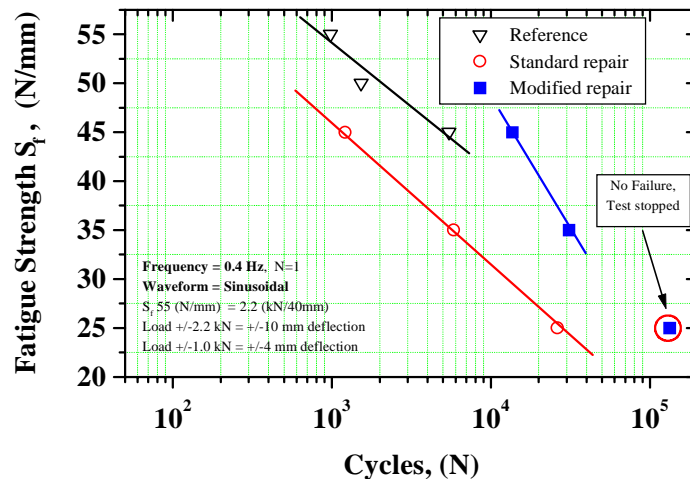
Figure 2. Fatigue cycles-to-crack initiation for GRP/Foam sandwich specimens, Type "C" repair.

A graphical presentation of fatigue results for all three classes of specimens, ie. reference, standard repair and modified repaired specimens are given in Figure 2.

The fatigue results, shown in Figure 1, clearly indicate approximately an order of magnitude higher fatigue resistance (number of cycles, N) for specimens repaired as per the modified repair method in relation to those repaired by the standard procedure. The selected fatigue strength range,  $S_f = 25 - 45$  N/mm, produced crack initiation, (ie. specimen failure point) in all repaired specimen except for one modified repair specimen tested at 25 N/mm which resulted in “run-out”, ie. did not develop fatigue failure. The results for the reference specimens relate to the fatigue strength obtained at higher loads and are not directly comparable to those for the repaired samples. Although, at one point,  $S_f = 45$  N/mm, the data lies between the two points for the repaired specimens, additional data points tested at the 35 and 25 N/mm level will inevitably cause the “run-out effect” for the reference specimens and thus produce unquantifiable results. Insufficient data exist to correlate fatigue cycles to failure (N) determined at different fatigue strengths ( $S_f$ ), however, it is reasonable to assume that

the order of fatigue performance of specimens restored by different repair methods is as follows: modified repair > standard repair. In addition, as the data at 45 N/mm indicates, the modified repair performance exceeded even that of the reference.

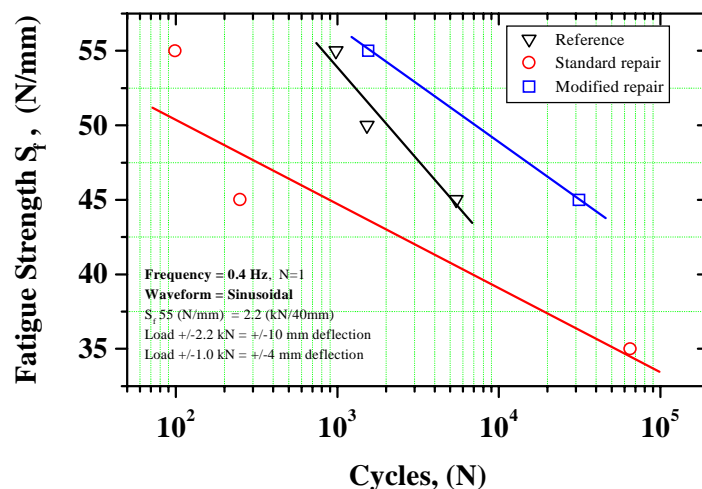
Figure 3. Fatigue cycles-to-crack initiation for GRP/Foam sandwich specimens. Type “B” repair.

The fatigue results showed that the modified repaired specimens, when compared with standard repaired specimens, had significantly higher fatigue life both in terms of cycles-to-crack initiation and cycles-to-total failure, see Figure 3. Unlike the difficulty of comparing the reference data with the Type C repair data, the reference data along with the Type B repairs data falls within the range of the standard and the modified repair data and hence provide easy comparison. In both batches, the crack initiation was in the adhesive bondline.
